*Early Domestic Architecture  
of Connecticut*

*By J. Frederick Kelly*

J. Frederick Kelly, A.I.A.

New Haven: Yale University Press

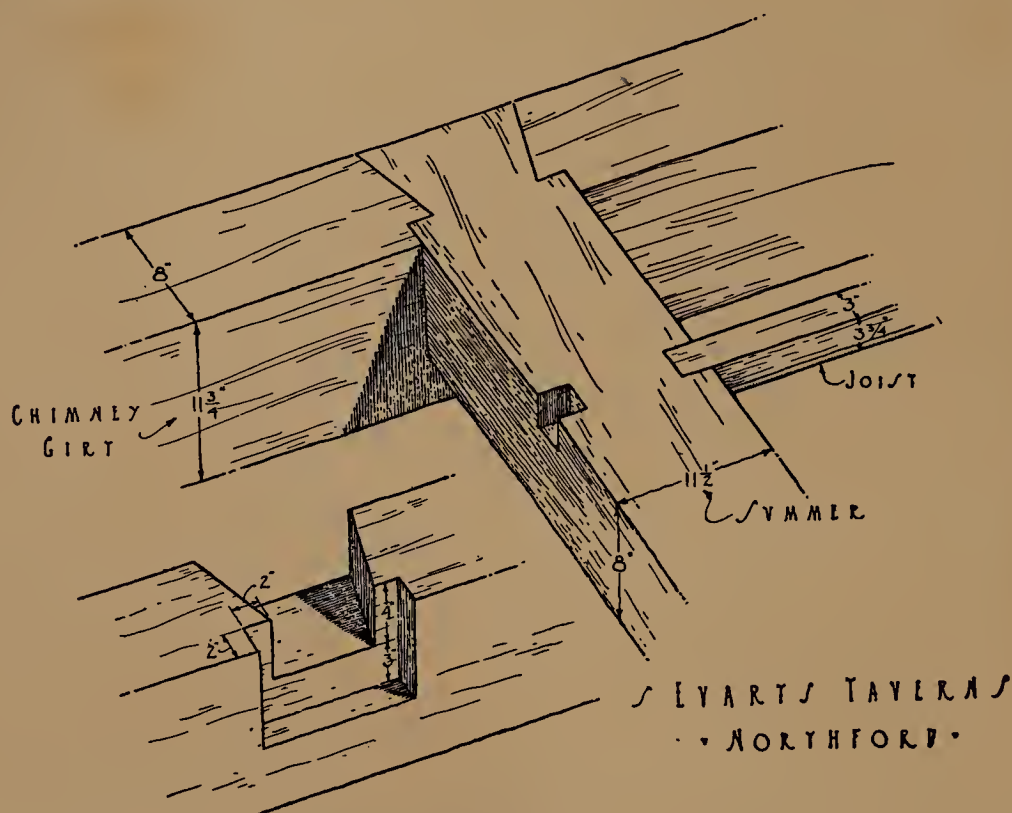
FIGURE 35.

It was the purpose of the summer to provide an intermediate support for the ends of the second-floor joists, which were framed into it on either side, from the front and rear girts. The conventional method of framing the ends of the summer into the girts which carried it was by means of a very ingenious dovetail joint, from which it could not possibly slip or pull out. (Figure 35.) Unlike most of the other framing joints, which were secured by means of heavy oak pins driven through the tenons, the ends of the summer were held in place merely by the weight of the beam itself.

As I stated in the chapter on framing, the ends of the summer, when it is in its conventional position, were framed into the end girt and the chimney girt by means of a dovetail joint. (Figure 35.) The advantage of such construction lay in the fact that the summer could not sag beneath the floor loads transmitted to it through the joists, unless it first gave way at the ends.

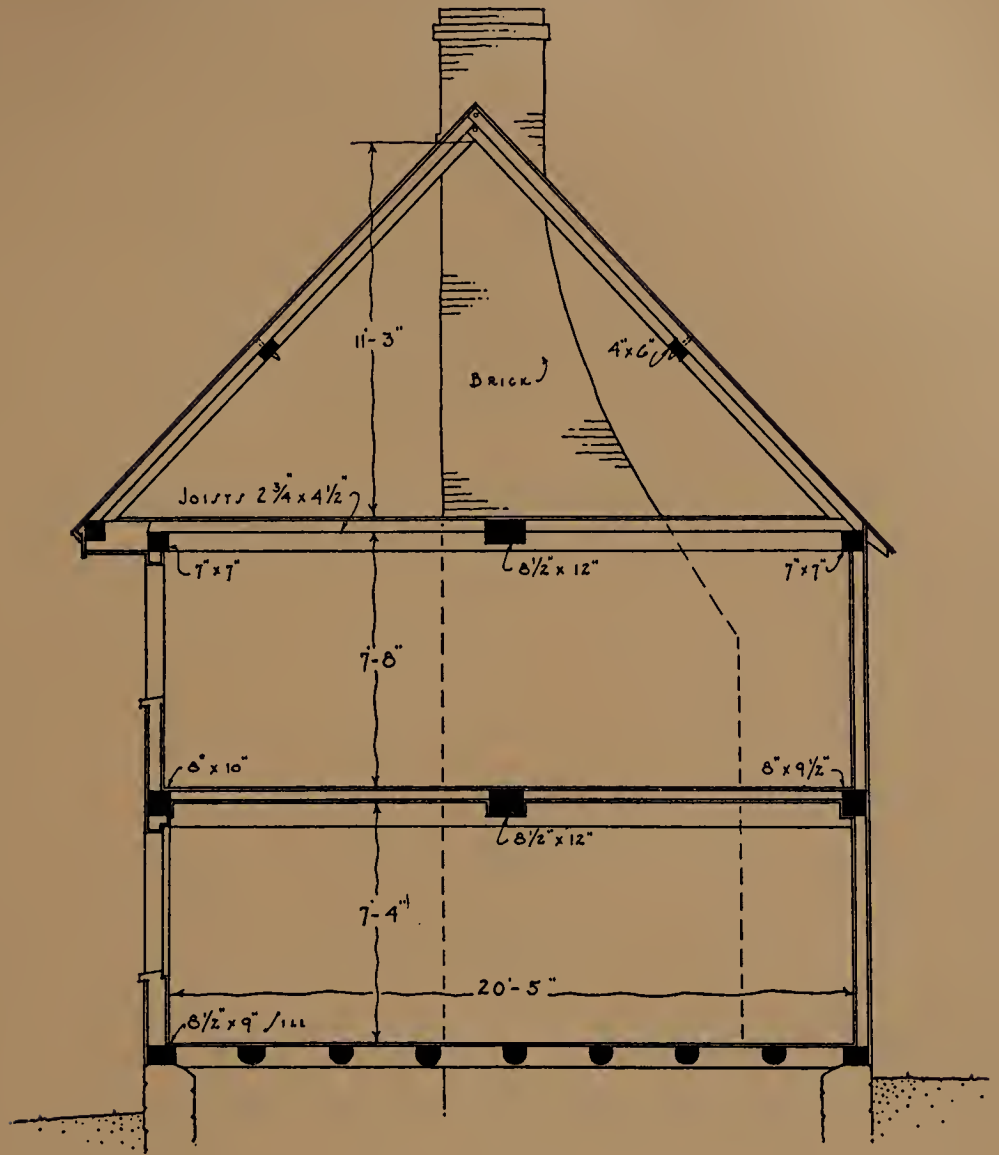
FIGURE 36.

• CROSS SECTION •

✓ OLDER WILLIAMS HOUSE - WETHERFIELD ✓

serve as a foundation for cornice construction. Much and varied ingenuity is to be seen in the various framing methods which were put into play. Perhaps the commonest practice was to frame a second plate out beyond the first plate, which was on the house line. From Figure 36, a typical example, it will be seen that the second plate is supported by the projecting ends of the second-floor girts, which are halved over the first plate where they cross it. Other forms of front plate framing are treated in detail in Chapter XII, The Main Cornice.

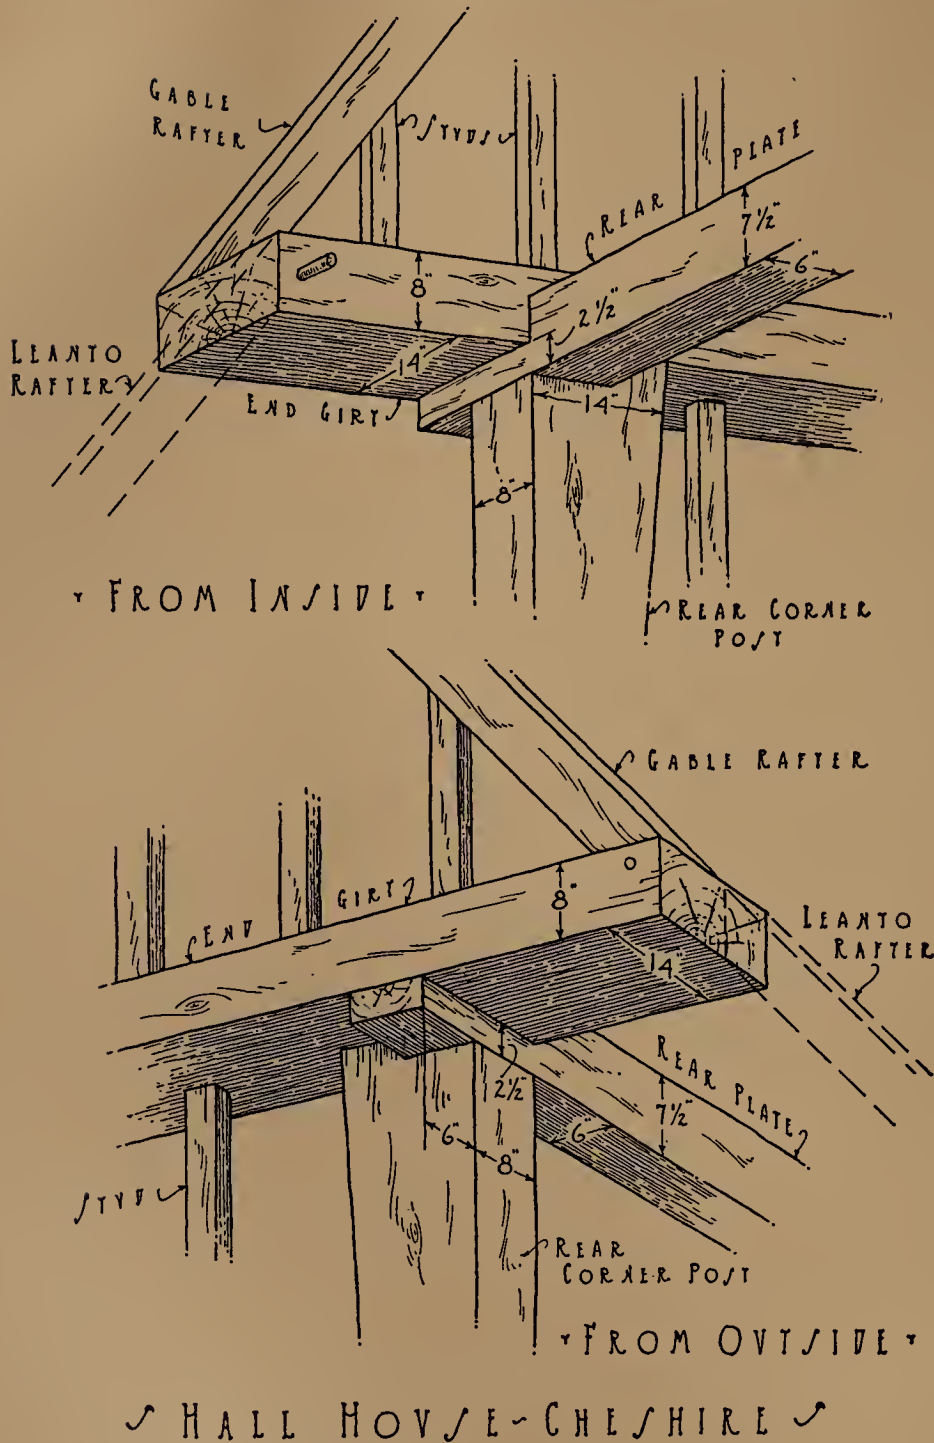
FIGURE 37.

Some variation is to be met with in the manner of framing the second end girts, which form the base of the gable. The projecting or overhanging gable was a common feature of early work, and it persisted in modified form until a late date. Where the gable does overhang, its projection is secured in one of two ways: either by framing out the end girt beyond the house line, by means of the supporting ends of the plates which were extended for that purpose; or by framing a second end girt outside the first one, which was in its usual position. The latter arrangement, which exists in the Stowe house, Milford (1685-1690), and the Moore house, Windsor (1664), is comparatively rare. A typical instance of gable overhang secured by framing out the end girt is to be seen in the Hall house, Cheshire (1730). Its construction is shown in detail in Figure 37. (Also see Plate XVII.)

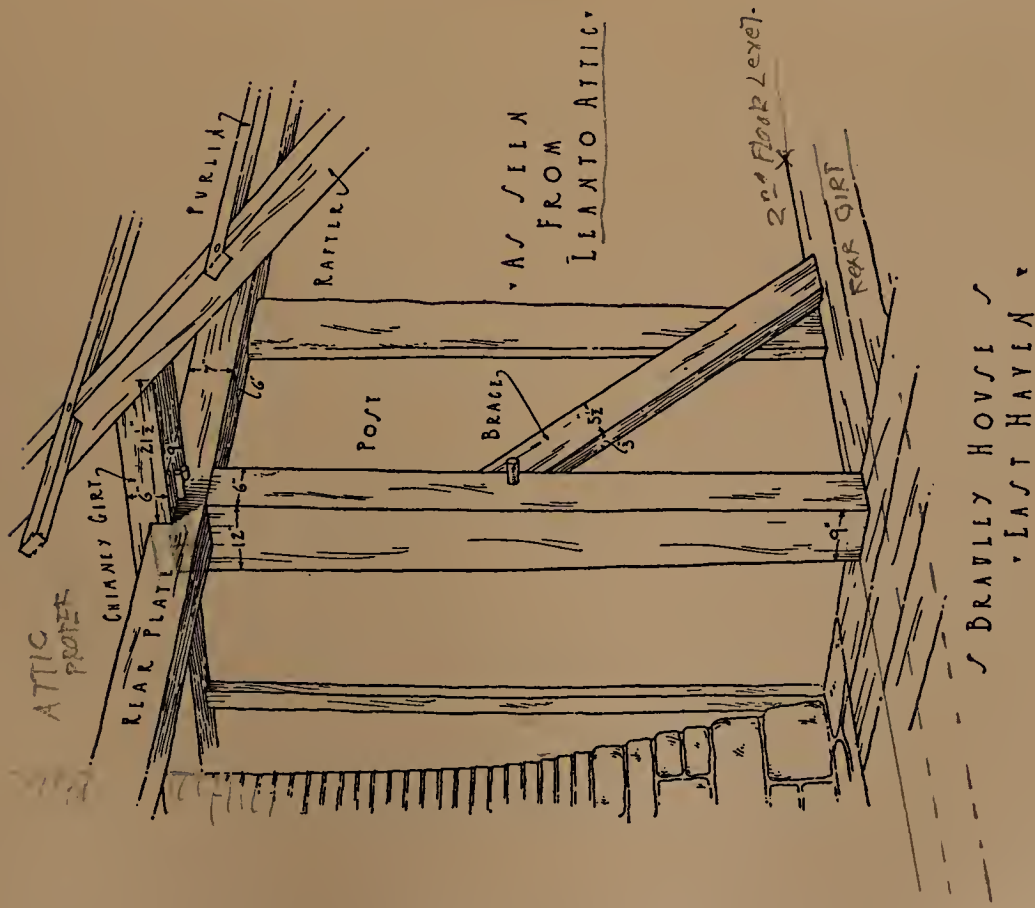
FIGURE 38.

Braces, when used, were commonly framed in diagonally between posts and first-floor girts; though very often the order was reversed, and the braces ran from the posts up to the plates and second end girts. (Figures 38 and 39.) Many houses display a complete system of bracing, which commonly occurs in outside walls.

This method of cantilever girt construction also appears as a characteristic of East Haven houses. The roof of the Bradley-Tyler house (*circa* 1745) is so framed (Figure 38), as is that of the Forbes or Barnes house (*circa* 1740). (Figure 65.) There is this difference,

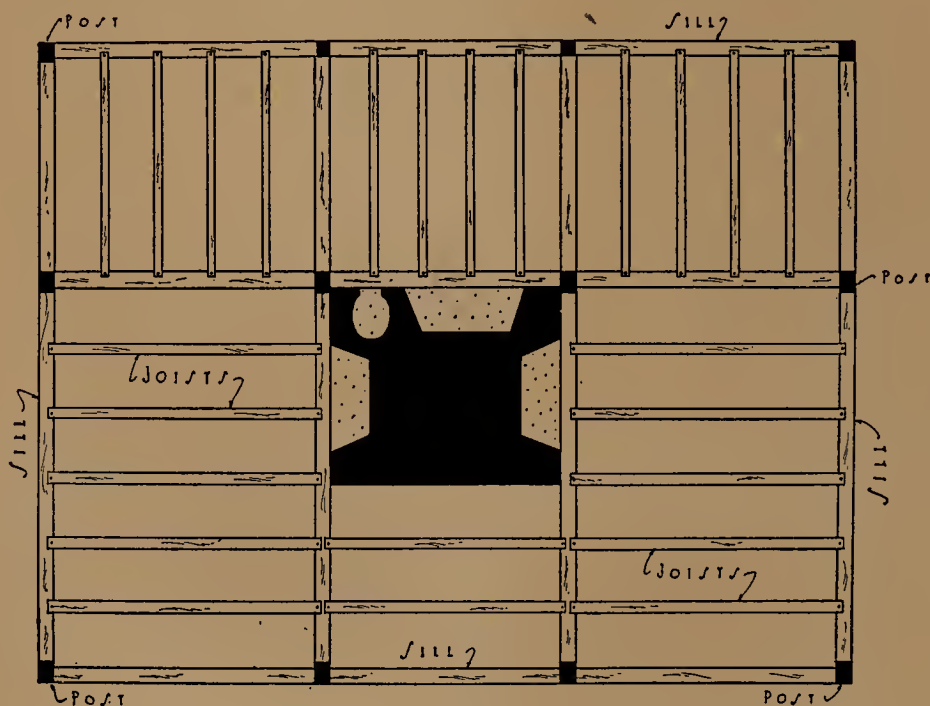
FIGURE 40.

✓ TYPICAL FIRST FLOOR FRAMING PLAN ✓

the floor boards could be nailed. As they were exposed only in the cellar, the bark was usually left on these joists, which were spaced from two to three feet on centers. In direction, the first-floor joists extended in almost every case from the end sills to the cellar chimney girts, so that they ran parallel with the front of the house. A typical first-floor framing plan is given in Figure 40. Occasionally a variation of this system is found, in which a cellar summer occurs. The joists are then framed into this beam, and run to it from the front and rear sills. Such an arrangement may be seen in the cross section of the Bidwell-Mix house in West Hartford (1695-1700), shown in Figure 12. The cellar summer in this instance measures 11 by 16 inches in section, and is broad-ax hewn on all four sides. A cellar summer may also be seen in the Stevens house, West Haven (1735), although in this case it extends from the front to the rear sill, and the first-floor joists are framed into

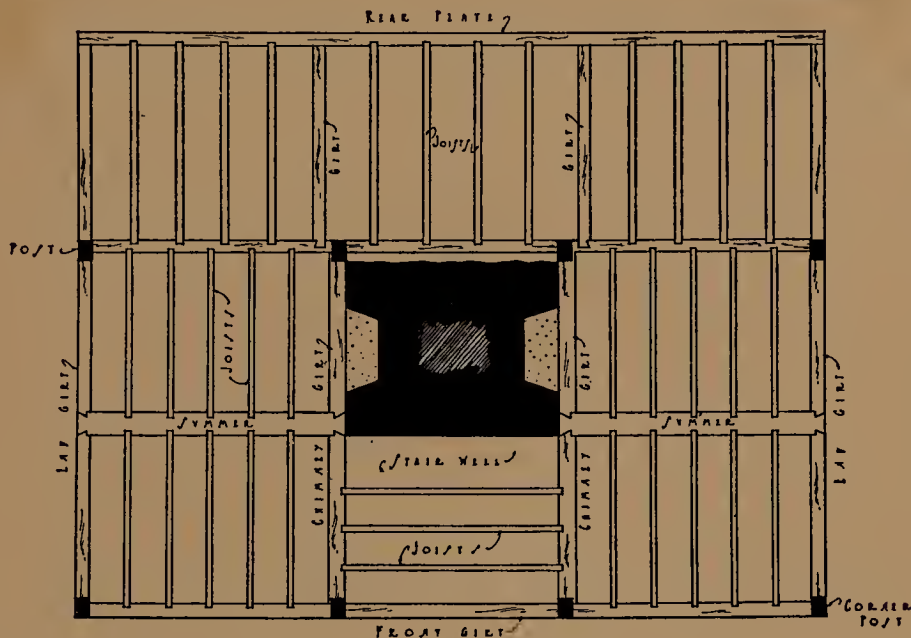
FIGURE 41.

A typical framing plan of the second floor of a house of lean-to type is shown in Figure 41, from which it will be seen that it very closely approximated that of the first or ground floor; the principal difference being in the decreased size of the floor joists, due to the presence of the summers. In the earliest houses, before the advent of plastering, the second- and attic-floor joists were left exposed, appearing against the ceilings or the under sides of the floors above them. Such joists were always of comparatively small size; sectional measurements of those in the Caleb Dudley house in North Guilford (*circa* 1690) show

✓ TYPICAL SECOND FLOOR FRAMING PLAN ✓

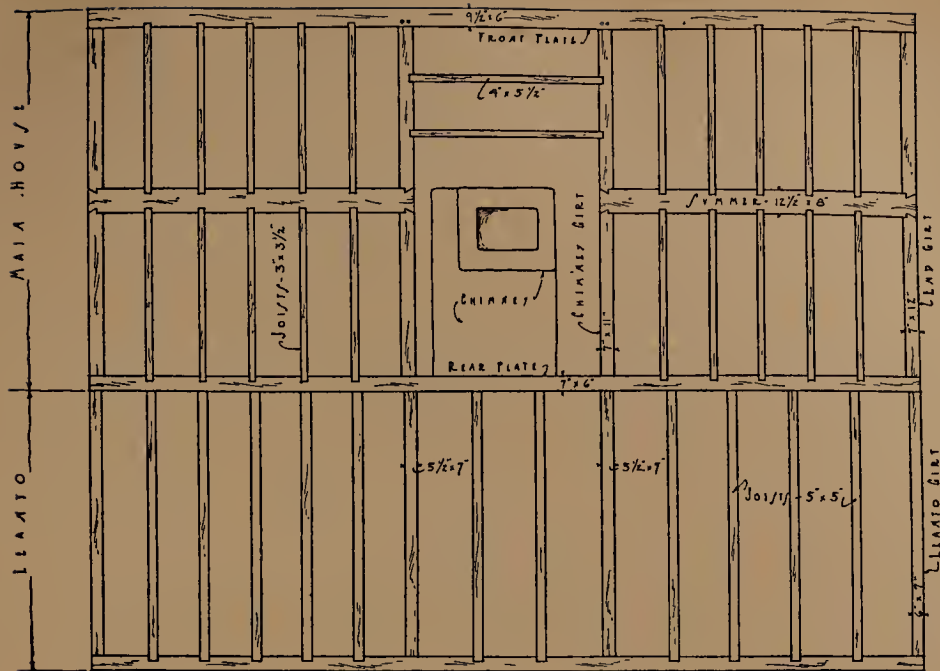
FIGURE 43.

• ATTIC FRAMING PLAN •  
 ✓ MOVETHROP HOVSE - EAST HAVEN ✓

borhood of twenty inches on centers. A framing plan of the Moulthrop house (*circa* 1690), which formerly stood in East Haven, is shown in Figure 43. It is typical of the central-chimney house of lean-to type.

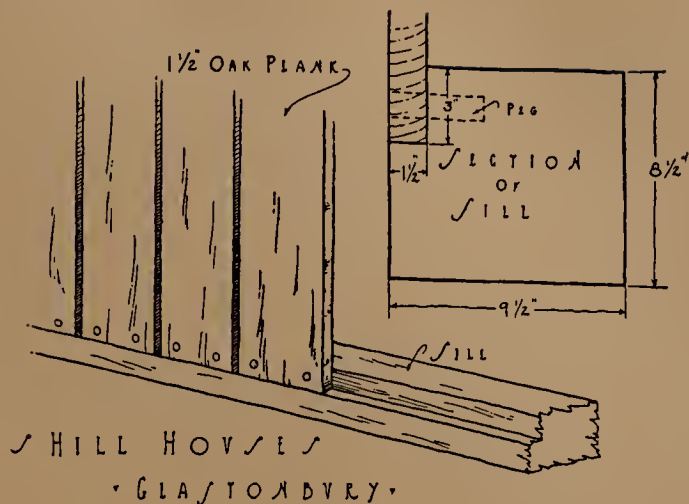
FIGURE 46.

town of Guilford (*circa* 1690) is a typical example, the planks were applied vertically, and extended in one unbroken length from sill to plate. Varying in width from 12 to 15 inches, or even more, they were secured to the main framework, which was the same as that of a studded house, by means of oak pins about three-quarters of an inch in diameter. These pins were driven through holes bored through the planks and into the sills, girts, and plates. Usually two pins were placed at each bearing. The planking of the Norton house is placed so that spaces of about two inches' width occur between the planks. These spaces were plugged with a mixture of clay and cut straw. In some cases, as Figure 46 shows, the planks were set into a rabbet cut in the sill.

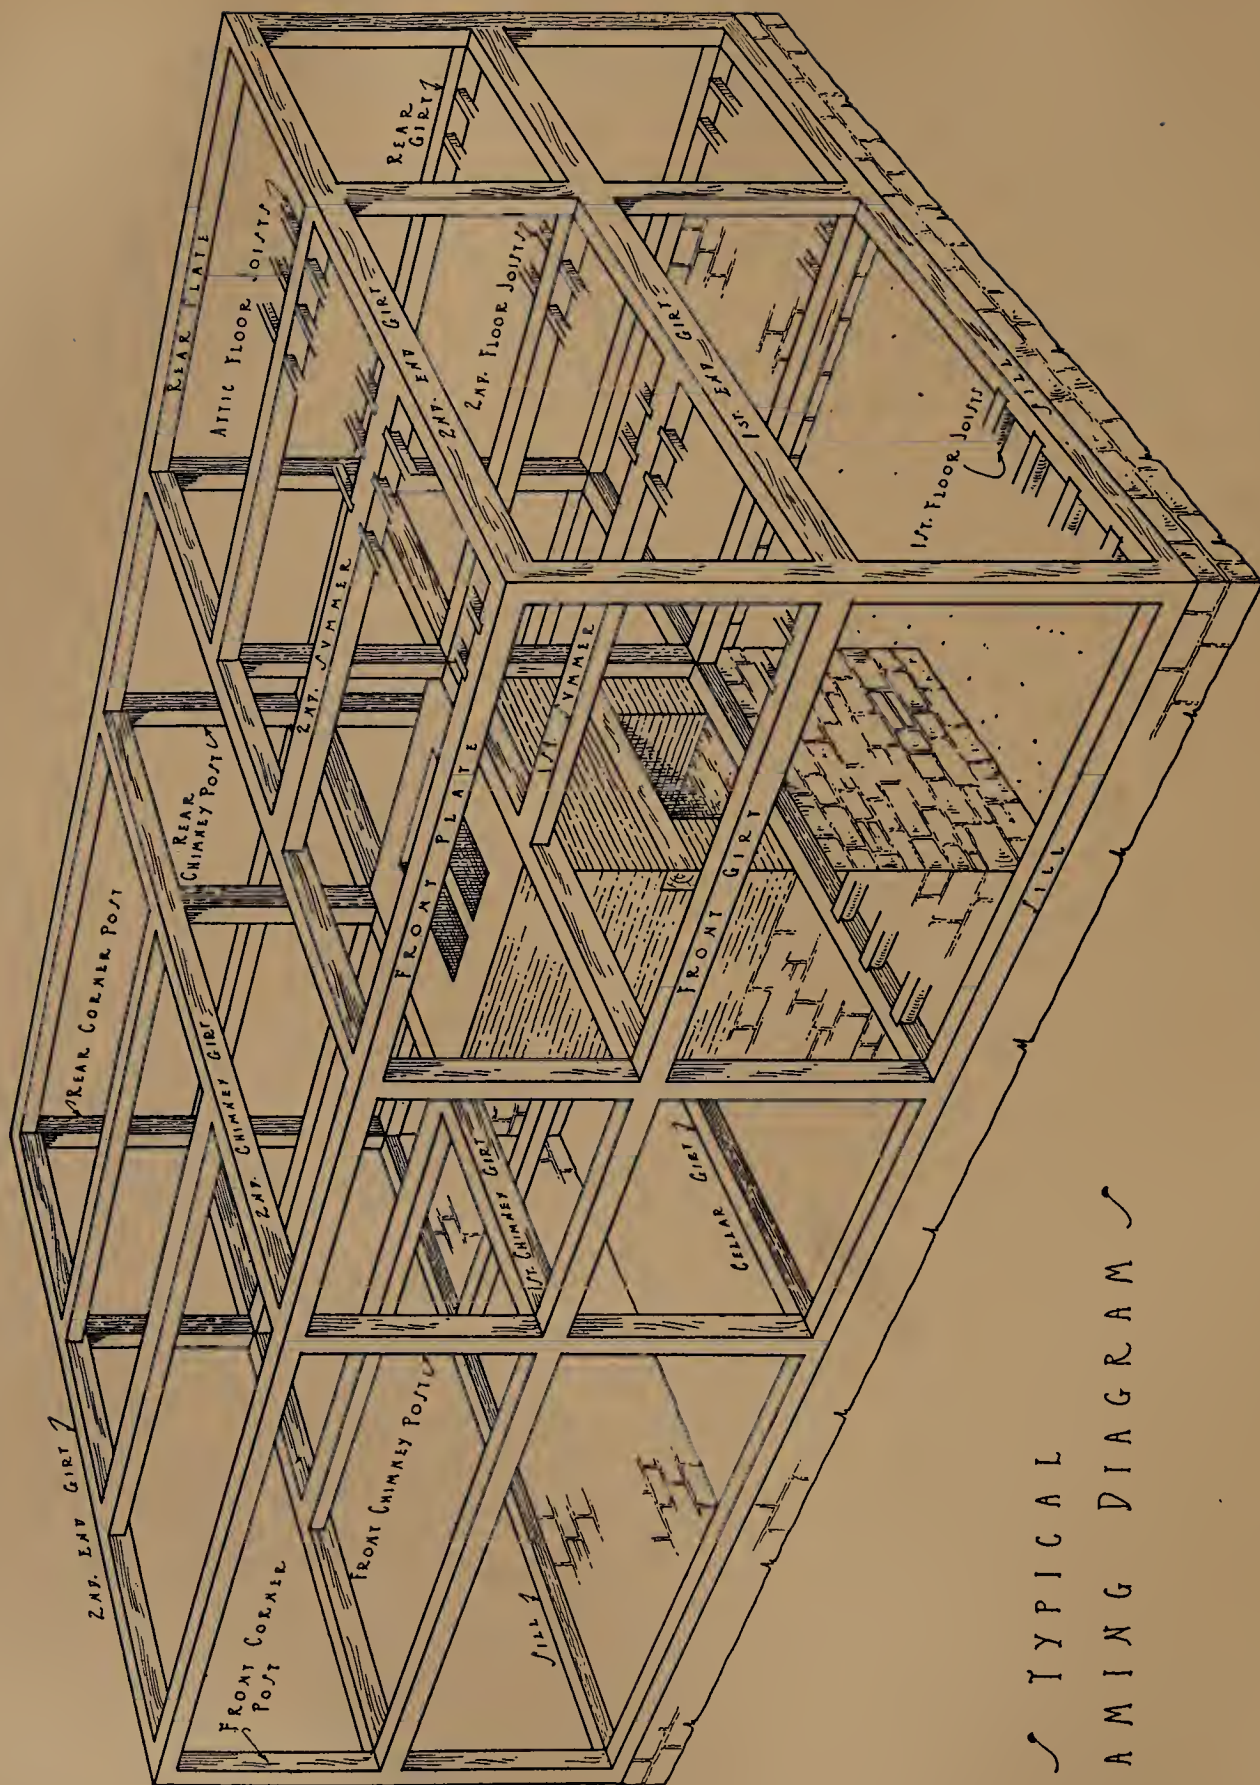
FIGURE 48.

TYPICAL  
 FRAMING DIAGRAM

During the next step, when the lean-to disappears and the house becomes of two full stories throughout, the full number of twelve posts is retained, and the framing remains as before, with the exception that the one-story rear posts are replaced by two-story posts similar to those in the front wall, and the rear plate is placed at the same level as the front one. What was formerly the rear plate, in the house of but one room in depth, now becomes a second summer of the second story; and the two chimney girts of the second story, as well as the end girts, are extended until they meet the new rear plate. (Figure 48.)

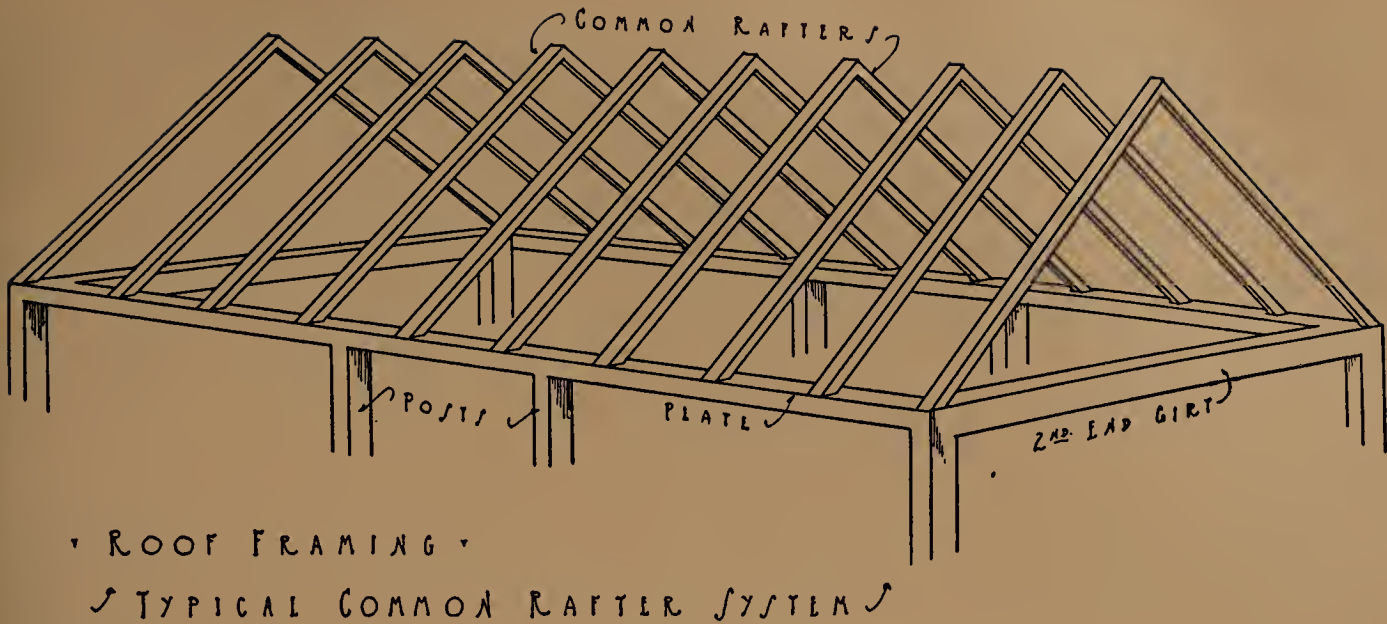
FIGURE 50.

Where the roof frame consisted of a system of common rafters, the spacing was generally from three to four feet on centers, and all the rafters were alike. (Figure 50.) A great deal of variation is to be met with in the sectional dimensions of such rafters; in some instances the section is nearly square, in others it is rectangular. Rafters of square section usually measure about 5 by 5 inches to 6 by 6 inches; those of rectangular section 5 by 7 or 6 by 8 inches.

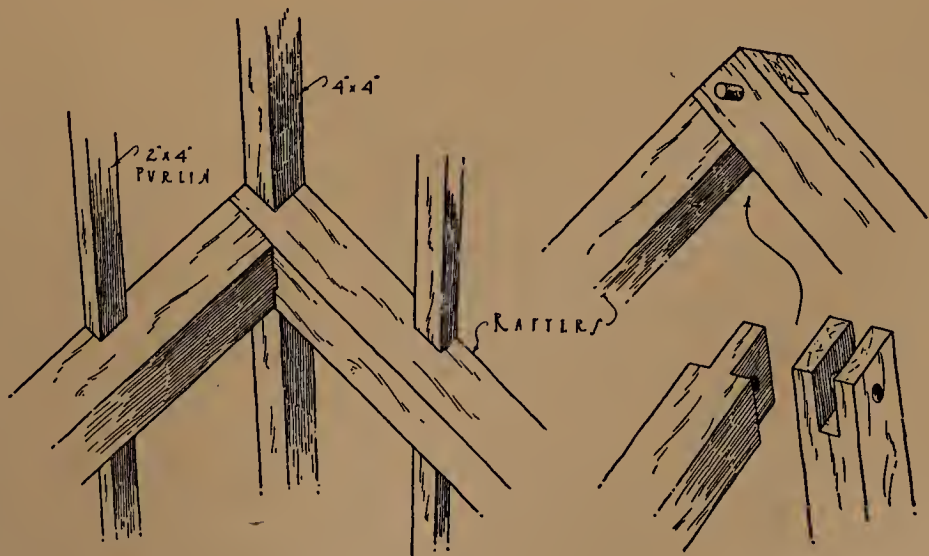
FIGURE 51.

more crudely built houses may be simply rough poles, dressed on one side, and still retaining much of their original bark. Where rafters meet at the ridge, they are almost invariably framed together by means of the tenon joint, as shown in Figure 51. The ridge-pole is never to be found except where it is part of a purlin system (Figure 52).

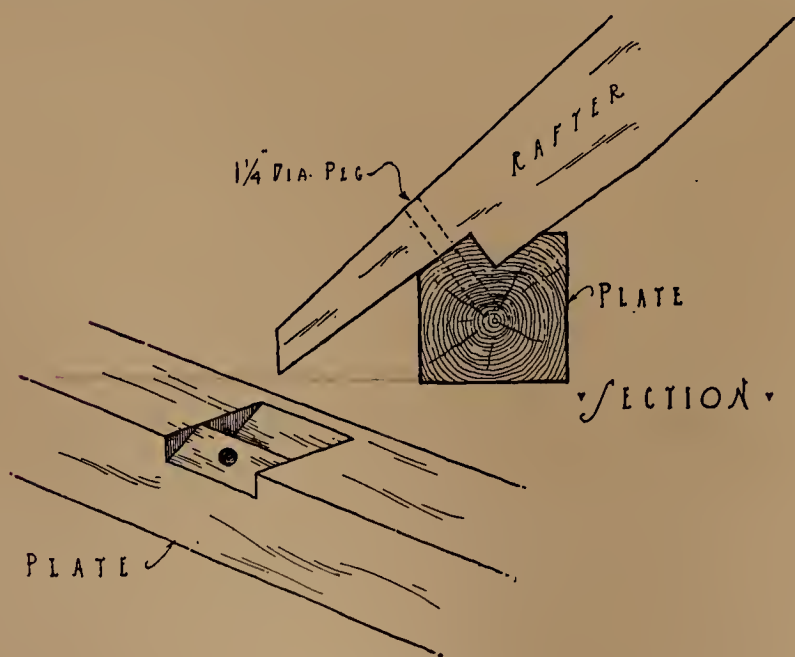
FIGURE 53.

The common method of securing a footing for the rafters was by means of a double notch cut into the plates at their point of intersection. (Figure 53.) This double step provided a bearing for the rafter butt, which was further held in place by means of a peg of about one inch diameter, driven through it into the plate.

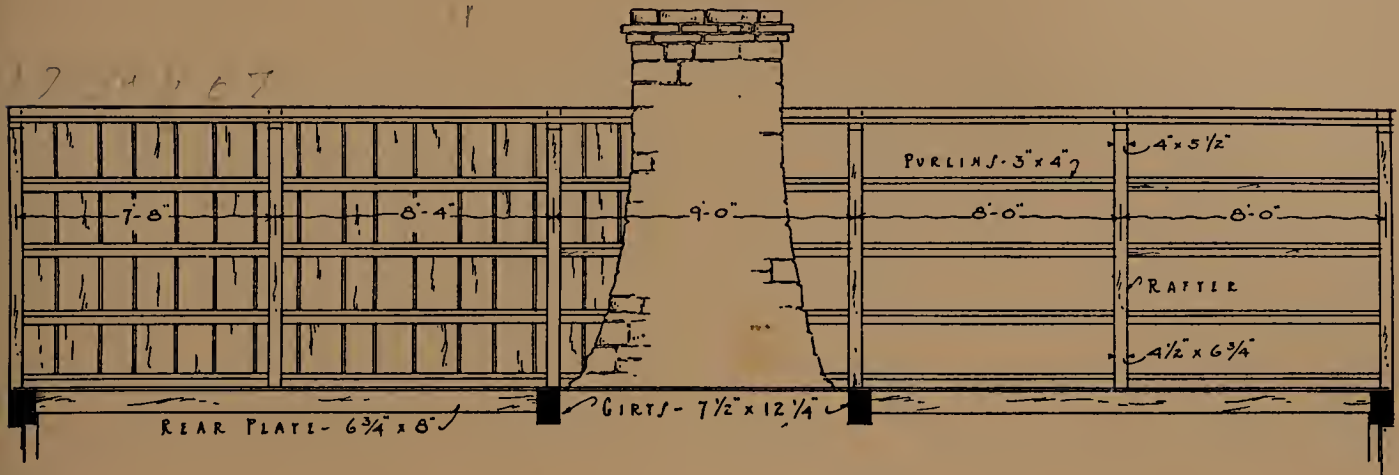
A typical system of purlin construction is to be seen in the roof of the Harrison-Linsley house in Branford (1690). (Figure 54.) This framework is made up of six pairs of principal rafters, which are of oak, hewn, and about  $4\frac{1}{2}$  by  $6\frac{3}{4}$  inches in section. These principals are spaced about eight feet on centers, with the exception of those forming the central bay, which are nine feet on centers. Into these rafters are framed the purlins,

SECTION SHOWING ROOF FRAMING

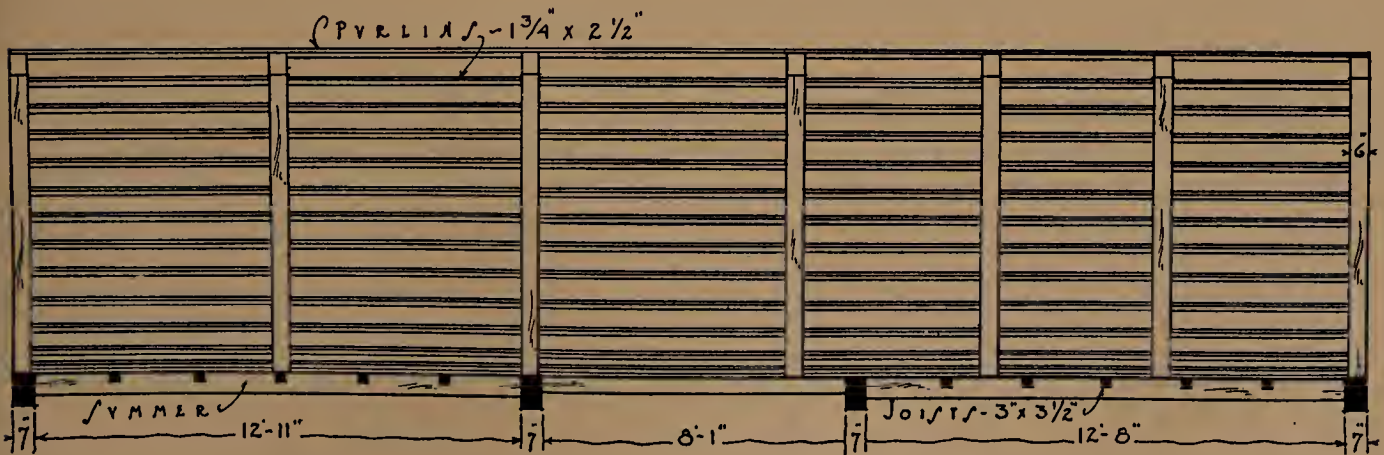
FIGURE 55.

LONGITUDINAL SECTION OF ATTIC - SHOWING FRAMING

MOULTROPHOUSE - EAST HAVEN

In the roof of the Moulthrop house in East Haven (demolished in 1919) there was to be seen a framing scheme of the utmost interest. (Figure 55.) Although made up of horizontal purlins and the usual rafters, this roof is not properly classifiable under the

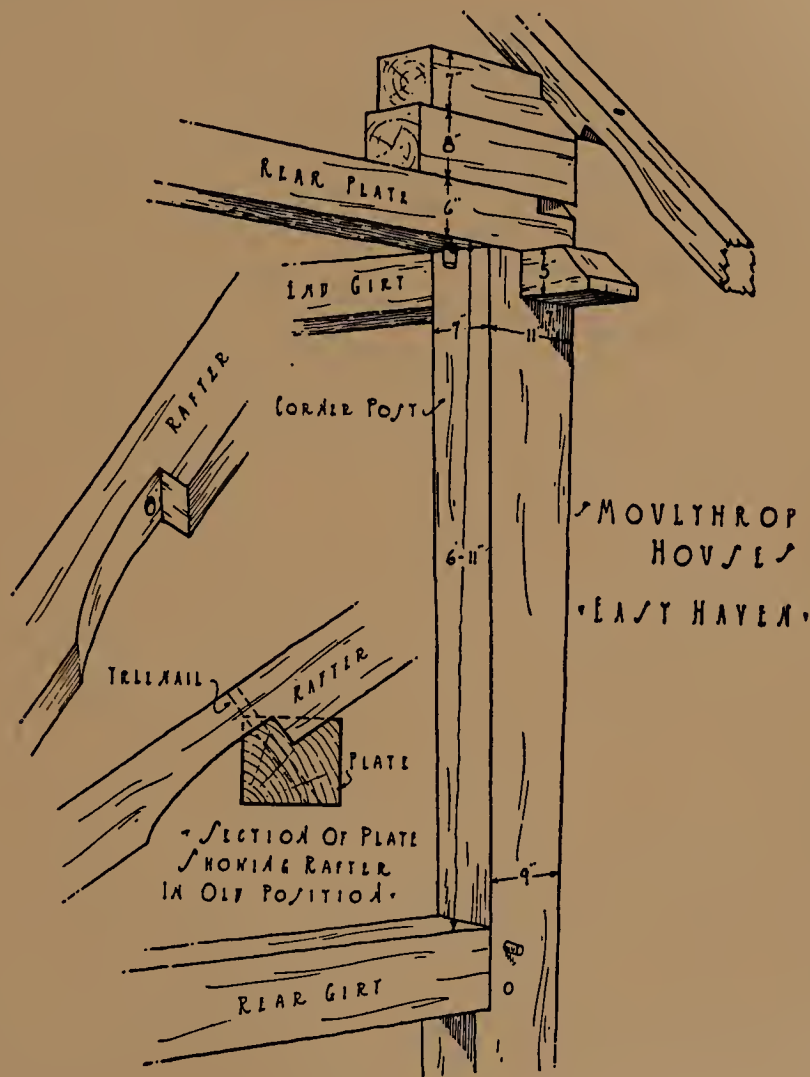
FIGURE 57.

In the framing of this roof, there is also written a novel bit of architectural history. From Figure 57 it may be seen that the rear or lean-to rafters have been raised out of the seats cut for them in the rear plate, and secured in a new position by means of oak blocks placed beneath them where they bear on the plate, and fifteen inches above it. In addition, each rear rafter has been lengthened about two feet by means of a new piece spliced on to its upper end. This blocking up and lengthening out of the rafters was made necessary by an increase in the depth of the lean-to rooms, which at some time in the history of the house must have been found necessary.

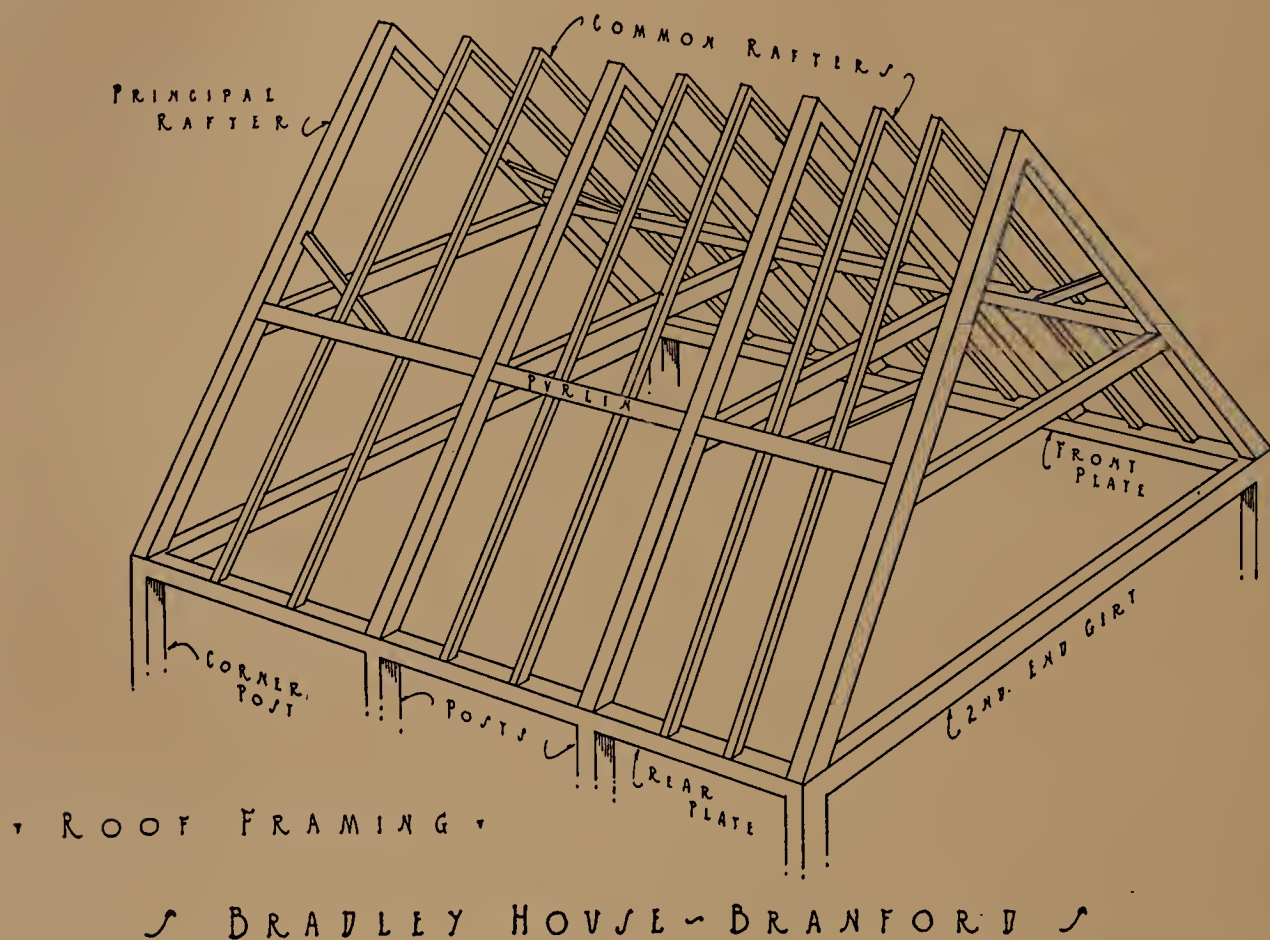
FIGURE 58.

Another variation of the purlin system may be seen in the roof of the Bradley house in Branford (*circa* 1730). This roof is framed with four pairs of very heavy principal rafters, which, with their unusually large collar beams, really form four sturdy trusses. (Figure 58.) These trusses, if so they may be called, carry two heavy purlins, which are framed into them. Into these purlins, in turn, two small rafters are framed between each two pairs

of trusses. The principal rafters, or legs of the trusses, it should be observed, are two inches heavier at the butt than at their apex. The steep pitch of this roof should also be noted. The roof of the Morris house at Morris Cove, near New Haven, is framed in a similar manner.

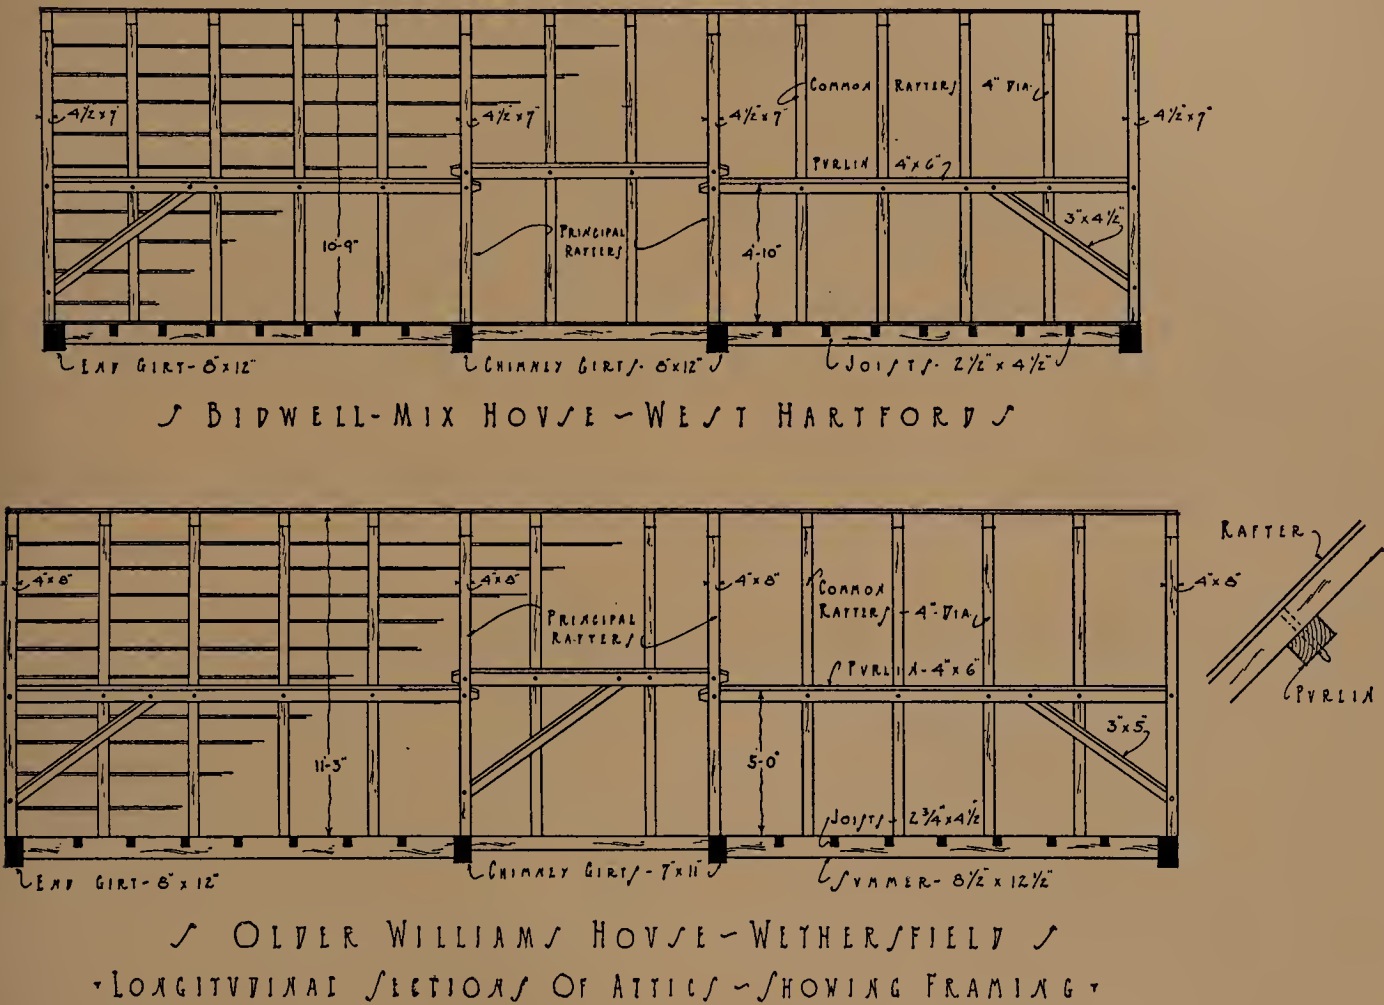
FIGURE 59.

A still different form of roof construction exists in the Bidwell-Mix house in West Hartford (1695-1700), and the older Williams house in Wethersfield (*circa* 1680). The framing of these two roofs is markedly similar, as may be seen from Figure 59. The system in each case consists of four pairs of principal rafters, measuring  $4\frac{1}{2}$  by 8 inches deep, of hewn oak, framed together at the ridge in the customary manner. A single horizontal purlin is framed in between every two rafters, and serves as a support for the

smaller common rafters which bear upon it, and which are held in place by pegs. These smaller intermediate rafters are simply rough poles of about four inches' diameter, slightly flattened on the outer side. In both of these houses, the end sets of rafters are above the end girts, and the central pairs above the chimney girts. Rafter feet and girts therefore meet the plate at the same point. (Figure 34.)

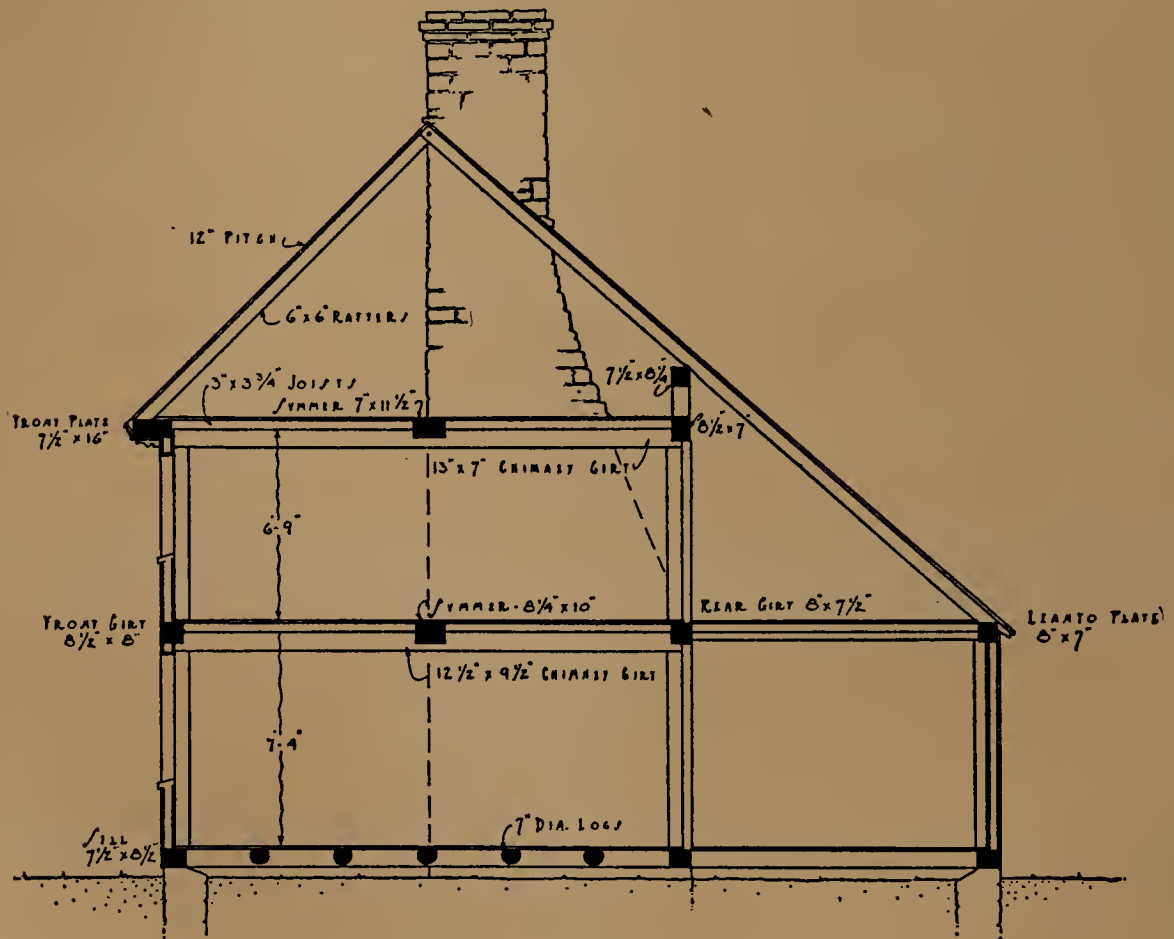
FIGURE 60.

In Guilford, Branford, and the surrounding region we find a group of houses, of which the old Evarts Tavern of Northford (*circa* 1710) is typical, and in which the desired additional width of lean-to was secured by the use of a second rear plate, from 18 to 24 inches above the first rear plate. This second rear plate served in reality as a purlin, and simply afforded an intermediate bearing for the long lean-to rafters. (Figure 39.)

• CROSS SECTION •

✓ EVARTS TAVERN - NORTHFORD ✓

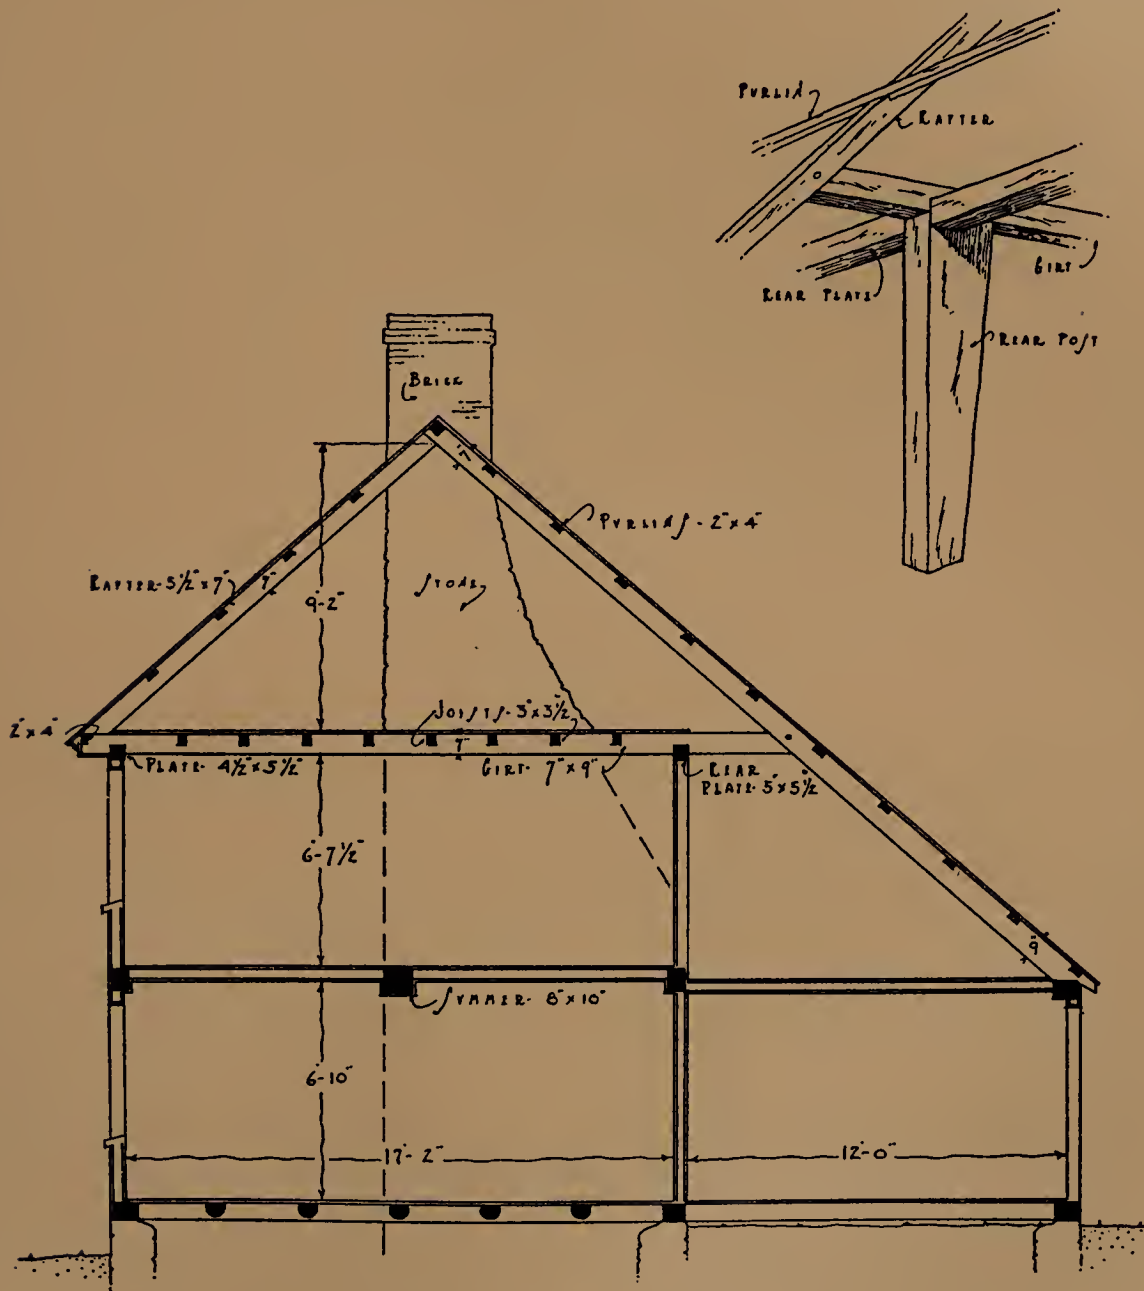
ported. (Figure 61.) The second-story summers, however, instead of running from end girt to chimney girt in the usual manner, were turned at right angles and extended from front to rear plate, so that their cantilevered ends provided bearings for the two rafters, each of which was intermediate between the end and chimney girts. (Figure 62.) Similar construction is to be found in the Hall house, Cheshire (1730), where the two intermediate girts above mentioned appear as summers against the second-story ceilings, running parallel

• CROSS SECTION •

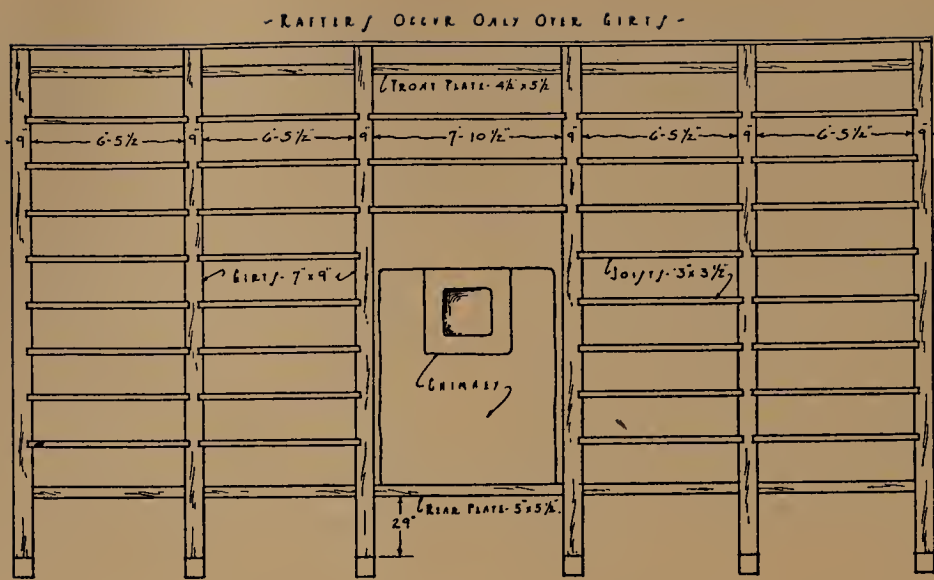
FIGURE 62.

• ATTIC FRAMING PLAN •  
 ✓ DEACON STEPHEN HOTCHKISS - HOUSE - CHESHIRE ✓

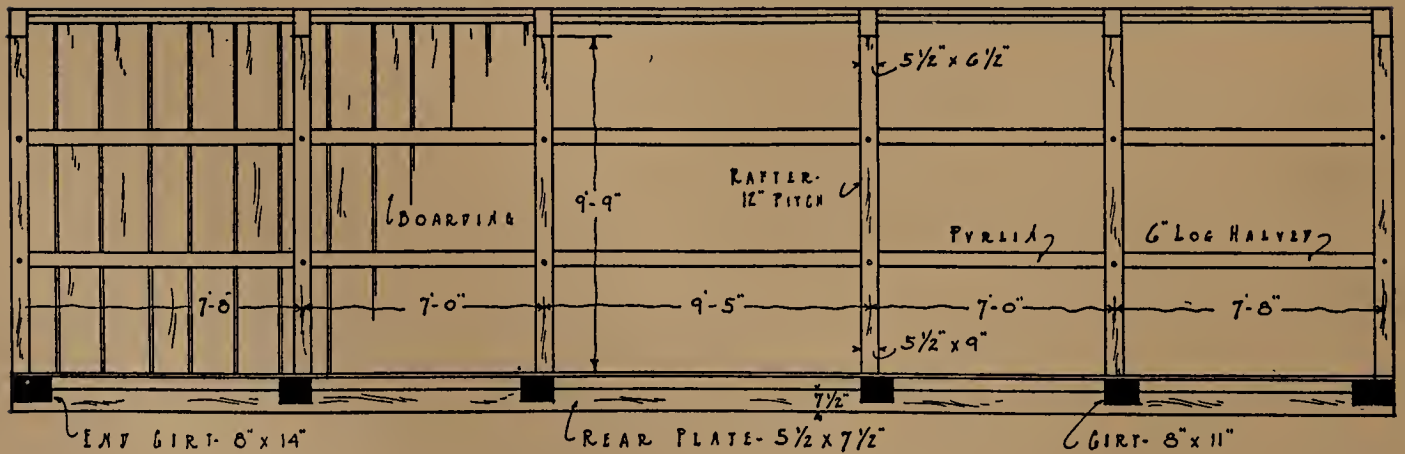
FIGURE 63.

• LONGITUDINAL SECTION - OF ATTIC - SHOWING FRAMING •  
 ✓ HALL HOUSE - CHESHIRE ✓

with the ends of the house. These two beams are cased, and have handsomely panelled soffits. (Figures 63 and 64.)
